Object: SMS Scharnhorst, 1915
Owner: National Maritime Museum

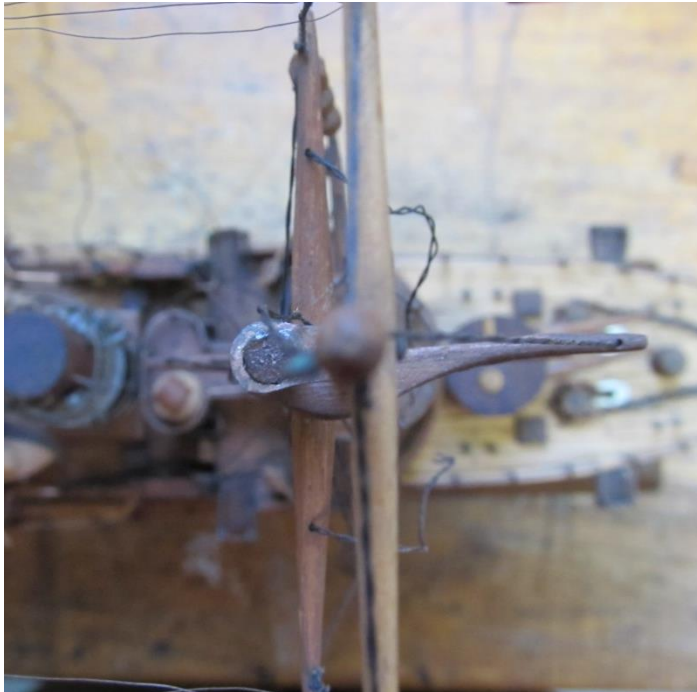
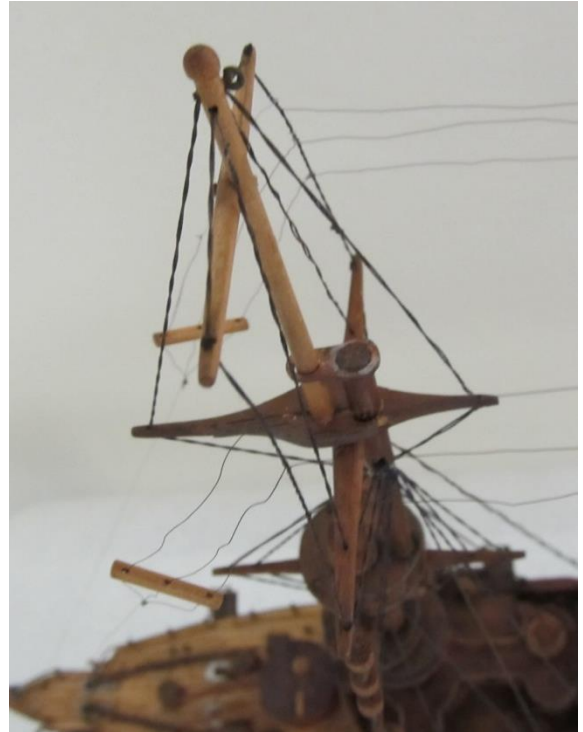
Old repairs on the mast were taken down using 50/50 acetone/warm distilled water poultices, starting with the aftmast. The rigging within the masts were sorted out and missing rigging was replaced only when necessary.
